FINAL SUMMARY OF HOUT BAY HOUSE RESEARCH PROJECT

Results of research focused on degradation of wood
in conditions of South Africa

Ing. Eliška Oberhofnerová, Ph.D.

2015-2019

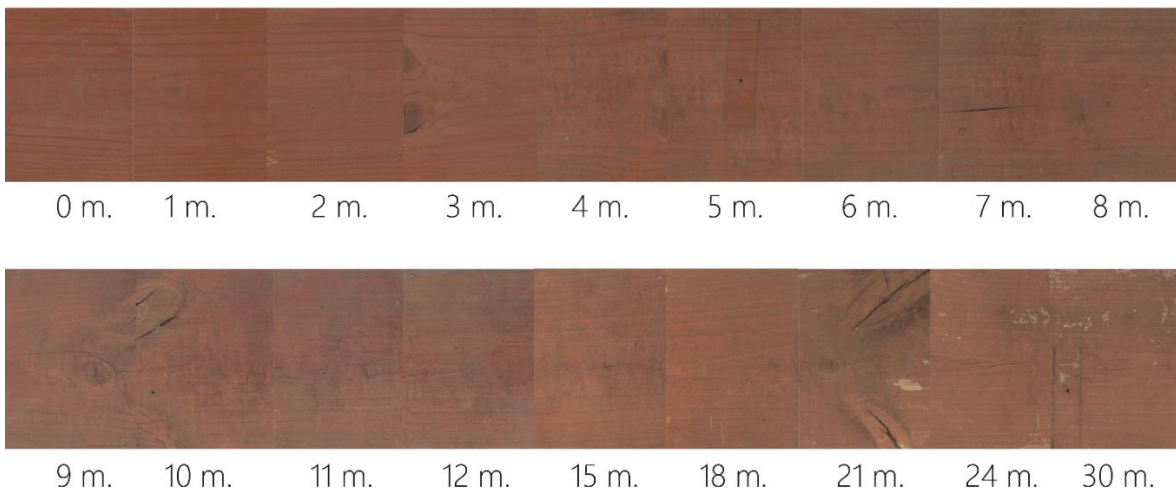
Figure 13: Visual appearance of pre-weathered pine during 0-30 months of weathering

From the evaluation of visual appearance of pre-weathered pine during 0-30 months of weathering (Figure 13), the gradual wood degradation of coatings can be observed. The coating started to degrade basically after 12 months of exposure, the peeling started approximately after 18 months of natural weathering. The total colour changes were higher in the comparison with the samples which were not pre-weathered. From that point, the initial pre-weathering did not improve the wood properties associated with coating application and weathering.
